SITE CERTIFICATION SUMMARY

This Site Certification Summary provides information about the **Painesville, Ohio, Site**. The U.S. Department of Energy Office of Legacy Management is responsible for long-term stewardship of the site under the **Formerly Utilized Sites Remedial Action Program**.

Painesville, OH, Site

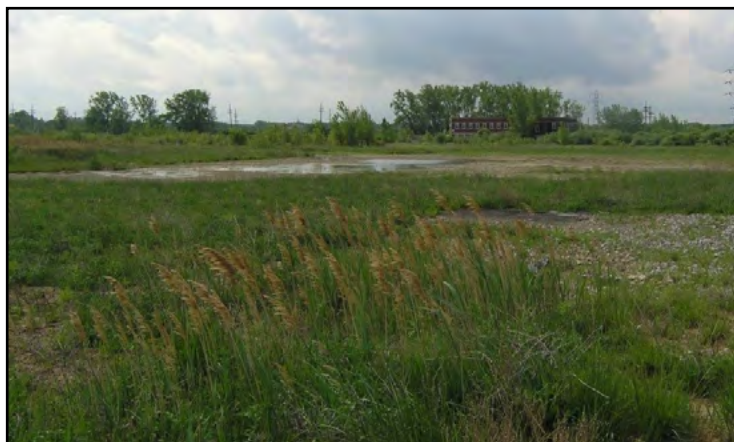
Areas of remediation and an old school building outside the Painesville site boundary (2013).

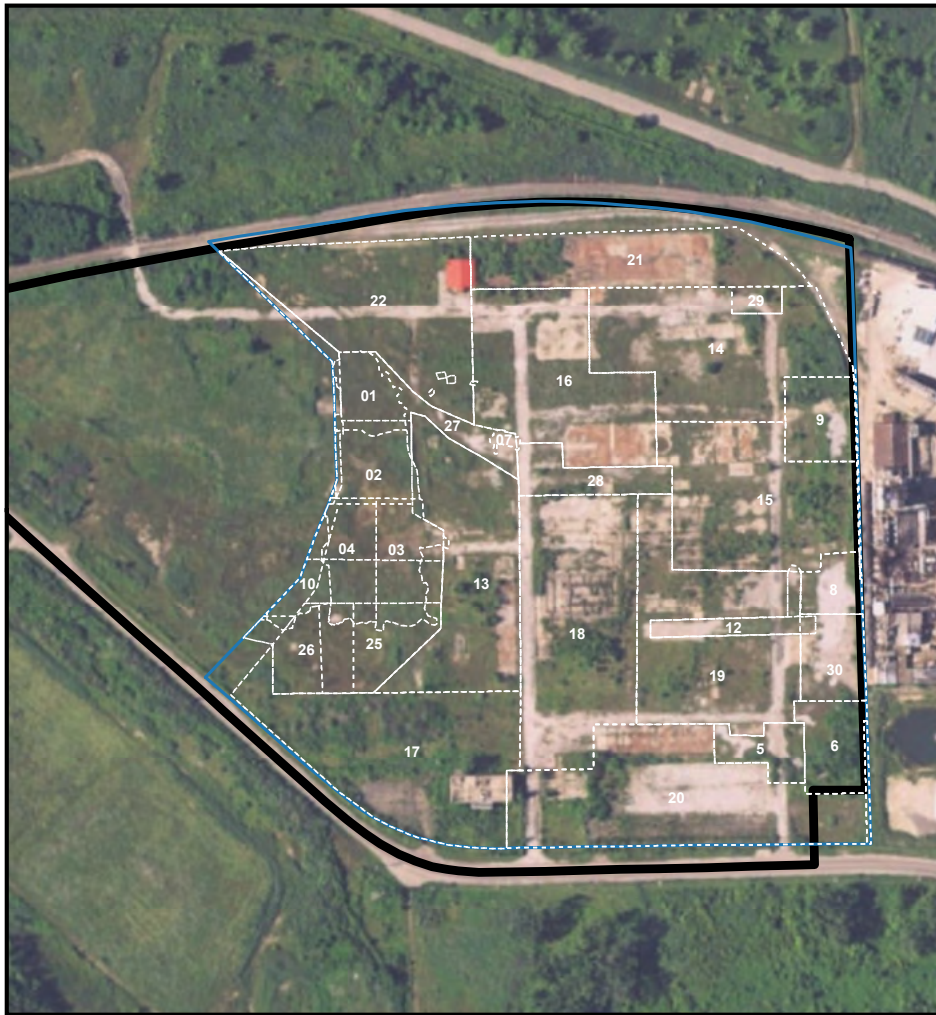
Painesville, Ohio, Site Map

- Final Site Survey Units
(Class 1 and Class 2)
- FUSRAP Site Pin
- FUSRAP Certified Site Boundary
- Original Site Boundary

For more detailed results of the post-remediation sampling, see the [Site Certification Data Summary Worksheet](#) on pages 4-5. For a more detailed map of the site and sampling locations, see the [Site Overview Map](#) on page 6.
